MR YORK'S REPORT.

THE CHOLERA INQUIRY COMMITTEE, APPOINTED BY ST. JAMES'S VESTRY, having been engaged several months in investigating any causes which might have existed in the autumn of 1854 to induce the propagation of Cholera, among which was the possibility of contamination of well water from defective house drainage, the Secretary was instructed to adopt the best measures for inquiring into, and reporting upon, the condition of the drainage at the house No. 40, Broad Street, it being immediately adjoining the parish pump in that street, which examination having been made at the close of April 1855, the following were found to be the results of his investigations:—

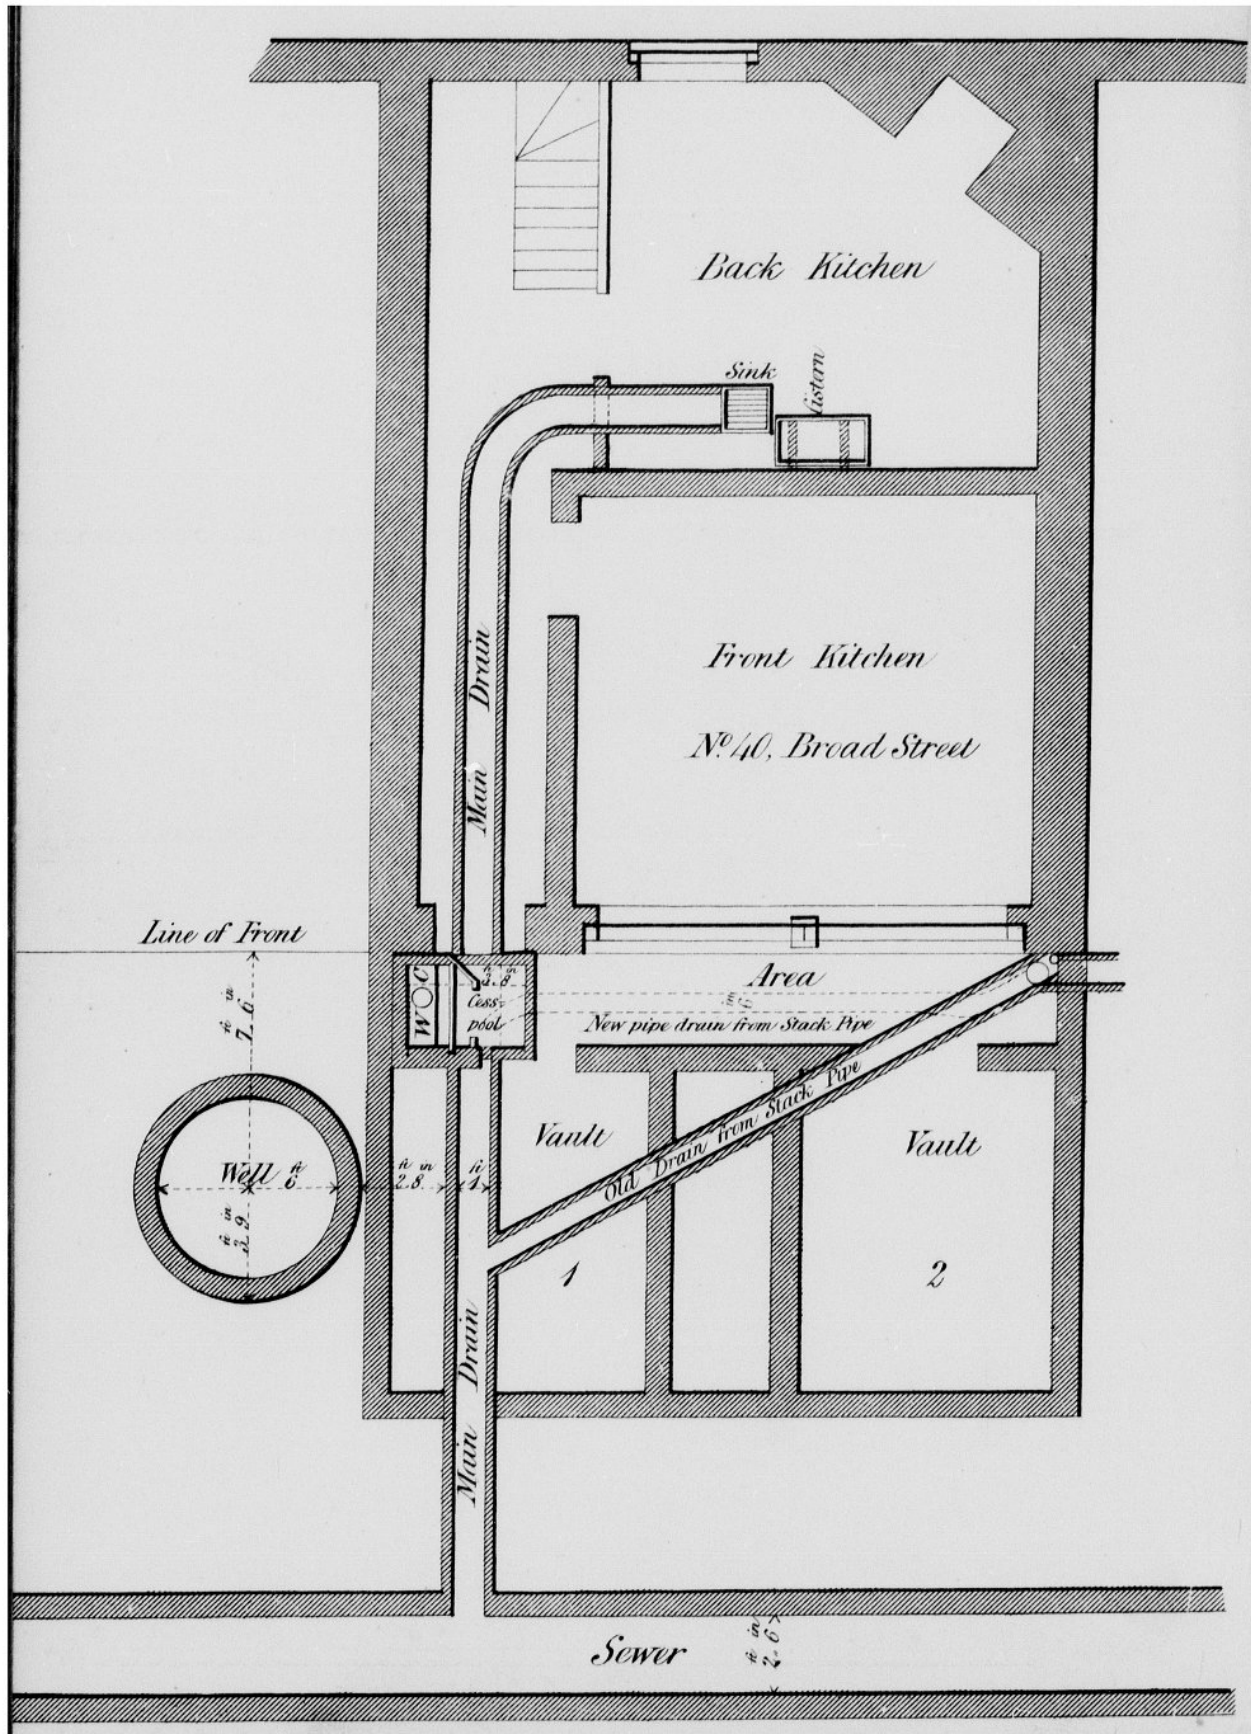
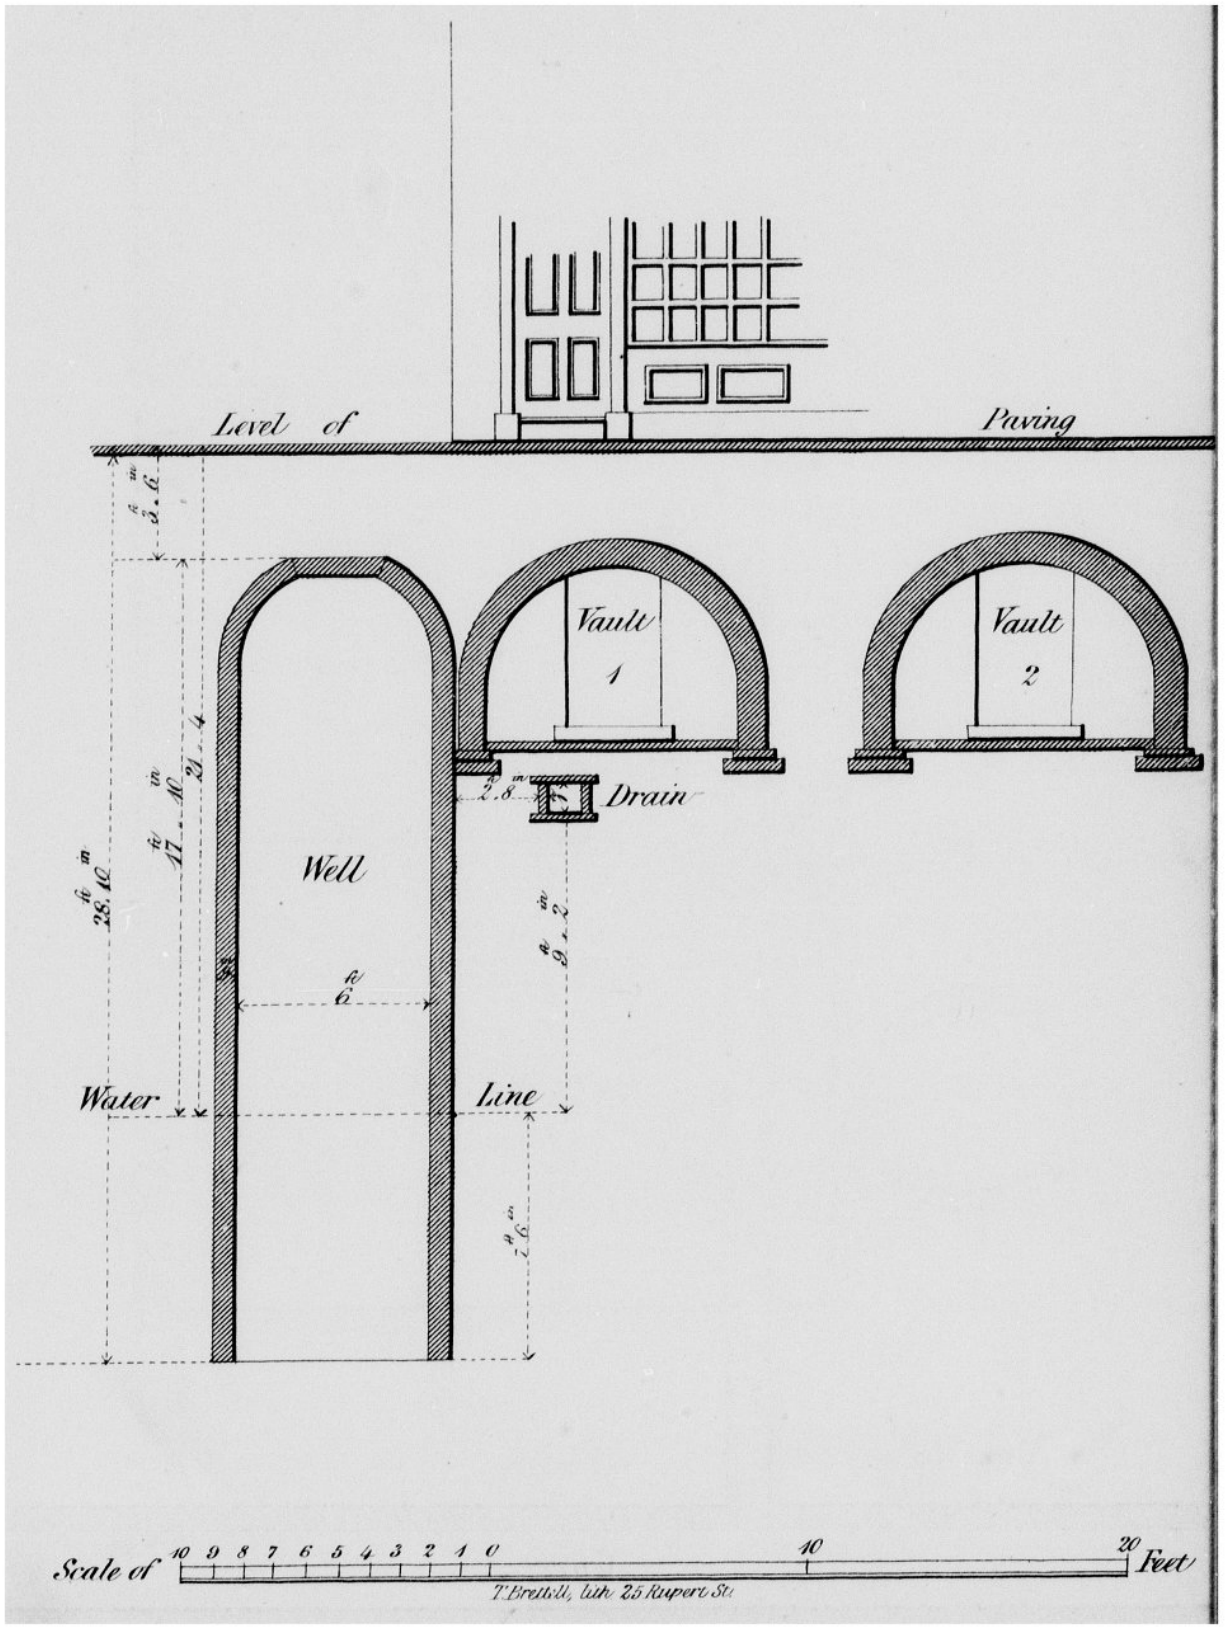
The main drain of the house was opened in the front vault under the street, and was found to be constructed on the old fashioned plan of a flat bottom, 12 inches wide, with brick sides, rising about twelve inches high and covered with old stone. As this drain had but a small fall, or inclination outwards to the main sewer, the bottom was covered with an accumulation of soil deposit about two inches thick, and upon clearing this soil away

the mortar joints of the old stone bottom were found to be perished, as was also all the jointing of the brick sides, which brought the brick work into the condition of a sieve, and through which the house drainage water must have percolated for a considerable period. Into this drain in the middle of the vault an intersecting smaller drain ran from the front stack pipe at the south-west angle of the front area, bringing the rain water from off the roof of the house, and also forming a communication with the drains of the adjoining house westward (No. 39.)

Upon opening back the main drain, a cesspool intended for a trap, but misconstructed, was found in the area 3ft. 8in. long, by 2ft. 6in. wide, and 3ft. deep, and upon, and over a part of this cesspool a common open privy (without water supply) for the use of the house was erected, the cesspool being fully charged with soil. This privy is formed across the east end of the area, and upon removing the soil the brickwork of the cesspool was found to be in the same decayed condition as the drain, and which may be better comprehended by stating that the bricks were easily lifted from their beds without any, the least force; so that any fluid could readily pass through the work, or as was the case when first opened, over the top course of bricks of the trap into the earth or made ground immediately under and adjoining the end wall eastward, this surface drainage being caused by the accumulation of soil

in, and the misconstruction of the cesspool, which was intended to prevent effluvia and vermin coming into the house from the main sewer in the street, but which in fact it facilitated rather than prevented. This point is worthy of notice, and a reference to the accompanying plan prepared by me will more fully shew its misapplication as well as demonstrate the fatal effect it would have in driving or forcing any deleterious fluid matter into the ground and parish well adjoining, by preventing its running direct into the current of the house drain.

The stone placed in and across this cesspool dipped about three inches into the fluid therein contained, and as the more solid matter became deposited in it, the fluid became reduced in proportion, and when opened on the 23rd of April, 1855, it had reached that state of solidity that hardly any passage for its egress from it was left ; it had in consequence commenced to overflow between the back of it and the end wall of the area, and through any other crevice at the sides of the covering which was composed of saturated rotten boards—the condition of this cesspool covering, together with the solid matter at the bottom, led me to believe that it must have been in this state for many months, but it could not possibly have gone on much longer without total stoppage. All this old drainage has been removed, the cesspool destroyed, and new tubular pipe drains with

In connection with the question of how far any communication can exist, and has existed between this defective drainage, and the adjoining parish well which supplies the Broad Street pump, a reference to the accompanying plan and section of the well and drainage of the house will I conceive set the matter at rest.

From the bottom of the house drain down to the water line in the well, a vertical depth of 9 feet 2 inches exists, and from the side of the drain horizontally to the outer side of the brickwork of the well, there is only a space of 2 feet 8 inches, whilst the side wall of the vault adjoining the cesspool actually abuts upon it; thus, therefore, from the charged condition of the cesspool, the defective state of its brickwork, and also that of the drain, no doubt remains upon my mind that constant percolation, and for a considerable period, had been conveying fluid matter from the drains into the well; but lest any doubt should arise upon this subject hereafter, I had two spaces of the brick steining, two feet square each,

taken out of the inside of the well,—the first, thirteen feet deep, from the level of the street paving, the second eighteen feet deep, and a third was afterwards opened still lower, when the washed appearances of the ground and gravel fully corroborated the assumption. In addition thereto the ground was dug out between the cesspool and the well to three feet below the bottom of the former, and its black, saturated, swampy, condition, clearly demonstrated the fact, as did also the small furrowed appearance of the underlying gravel, observed from the inside of the well, from which the fine sand had been washed away during the process of filtration.

In conclusion, I have to state that nearly the same condition was observed in the ground between the street sewer, and the end wall of the vault through which the main drain passes outwards; I presume, therefore, it is manifest to all that, the owner and the occupier of this house had both neglected to improve its drainage by not availing themselves of the facilities afforded them for doing so by the construction and use of the new sewer carried through the western half of Broad Street in the years 1851-2.

cemented joints, and a syphon trapped closet have been substituted. The drain inside of the house which leads from the front area to the back kitchen has not been disturbed, it appears to be used only for the carrying off of waste water from a sink near the cistern, but should the street pump continue to be used hereafter, it will be necessary to have this drain reconstructed.
